11-PA-11090700-044

Assessment and Management of Eurasian Watermilfoil on Crooked Lake and Duck Lake

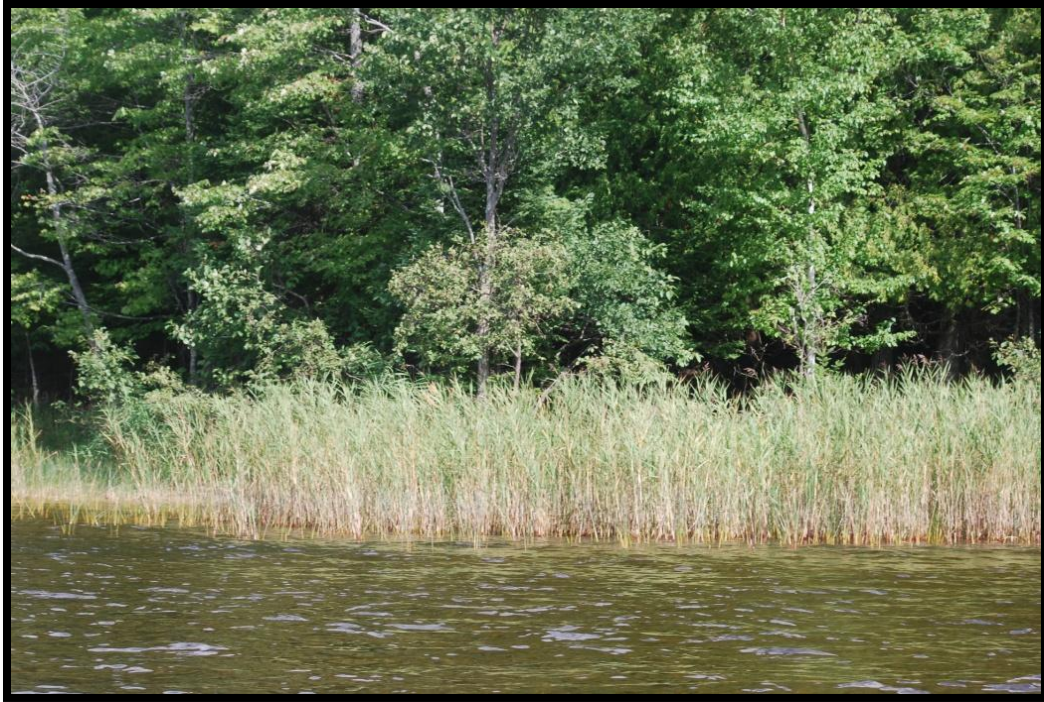
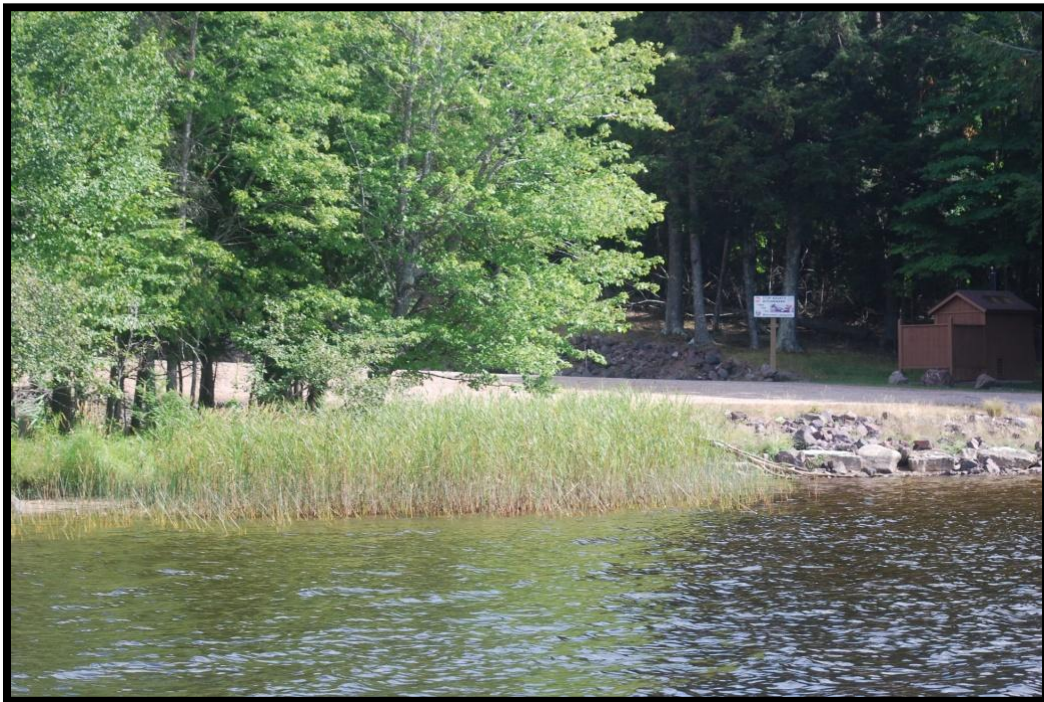
**Figure 12: Location of *Phragmites*, Duck Lake 2011**

In 2002 the ERDC conducted a vegetation assessment on Duck Lake. The only potentially aggressive plant species that was recorded at that time was *Phragmites australis*. *Phragmites* was not sampled during the 2011 survey, however it was recorded near several sampling points (Figure: 12). This plant has the potential to become an aggressive shoreline colonizer, displacing native vegetation by creating monotypic stands. In addition to *Phragmites*, reed canary grass was also observed during the survey (Figure: 13). This plant was not recorded during the 2002 ERDC survey. As with *Phragmites*, reed canary grass can potentially displace native vegetation.

*Phragmites* in Duck Lake

*Phragmites* near the boat launch, Duck Lake

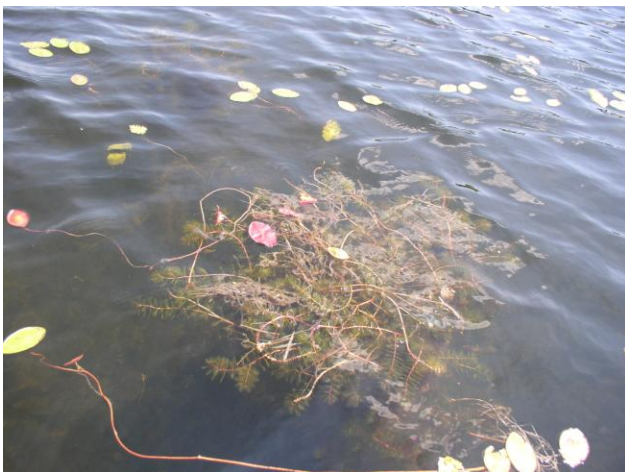
In 2005 the first infestation of EWM was discovered in the southwest bay of Duck Lake. Since then, EWM has spread to many areas throughout the lake at varying densities. The Duck Lake Homeowners Association has worked vigilantly since 2005 to keep EWM at low densities and reduce the probability of spread internally but also externally to other lakes. The two primary management tools used are seasonal herbicide treatments and a ongoing seasonal hand pulling/diving program. In 2011 alone approximately 380 hours of volunteer time was dedicated to EWM management.

Initial EWM found in 2005
